ACW BLOCK SEAWALL TESTING 2D PHYSICAL MODEL

Report MHL 2276 April 2014

prepared for Australian Coastal Walls Pty Ltd This page intentionally blank

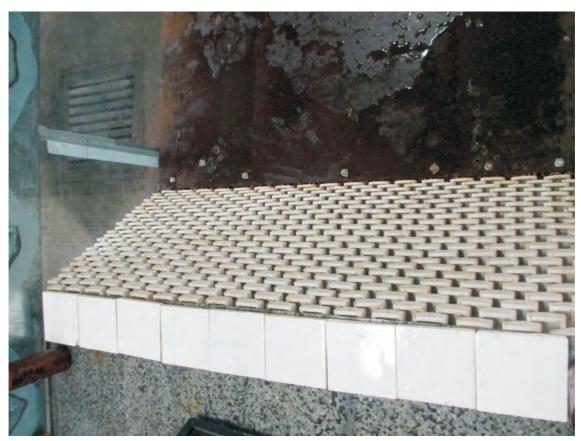
a) Cross-section 1 - placement density 11.9 units/m², WL 1.5m AHD, after testing with 2000 waves, view from above, no damage

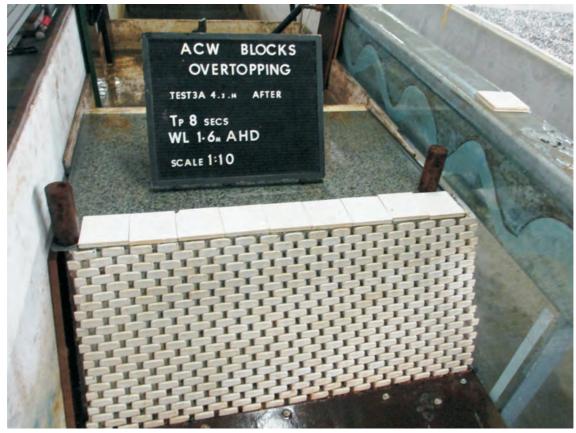
b) Cross-section 1 - placement density 11.9 units/m², WL 1.6m AHD, structure after testing indicating no damage

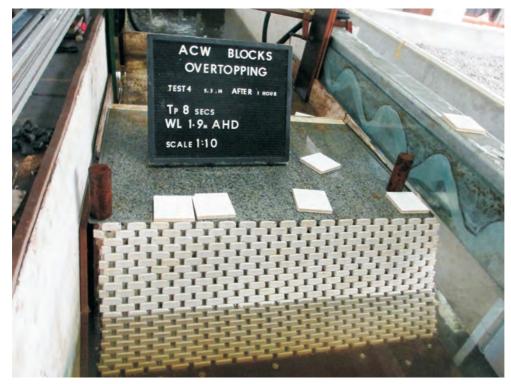
5	1-year +SLR, water level and waves breaking offshore	1.6	13.35-15.8	Not applicable	2.34, 8.10	No damage to wall, capping displaced
6	100-year + SLR and waves breaking offshore	1.9	26.8-30.3	Not applicable	2.26, 8.10	Wall deemed to be stable (<1% damage), capping displaced

b) Cross-section 1 - placement density 11.9 units/m², WL 1.9m AHD, after 2000 waves, capping dislodged

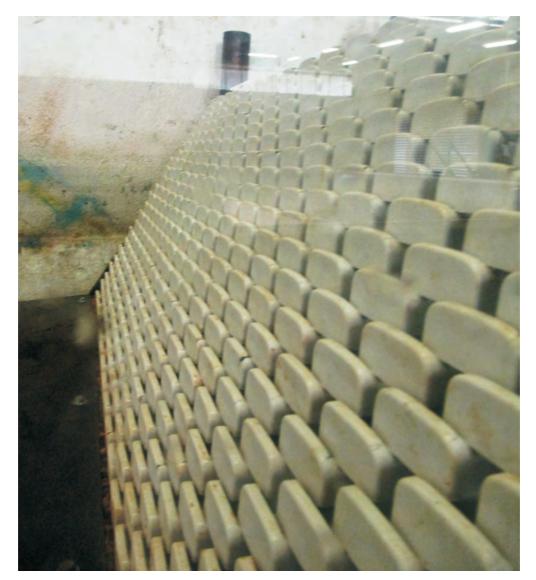
c) Cross-section 1 - placement density 11.9 units/m², WL 1.9m AHD, after 2000 waves, no damage to wall

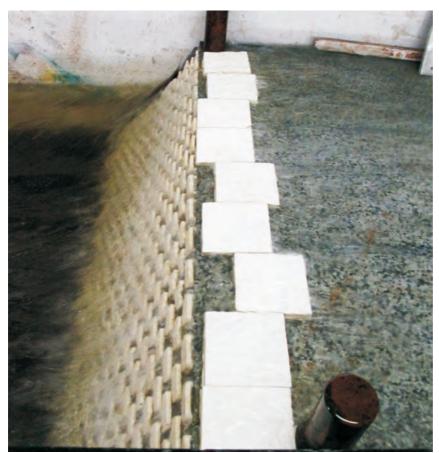
a) Cross-section 2 - placement density 10.8 units/m², WL 1.9m AHD, displacement of capping during testing

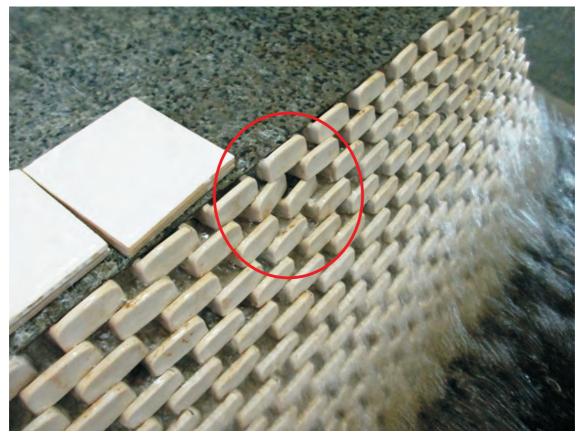
b) Cross-section 2 - placement density 10.8 units/m², WL 1.9m AHD, after 2000 waves. Note displacement of three units resulting in minor damage (<1%) on the wall in addition to displacement of capping

- Stability of sea wall section 2 placement density 10.8 units/m², 3.45 m AHD crest level. Tested at water levels 1.5 m AHD (100-year ARI water level), 1.6 m AHD (1-year ARI +0.4 m for SLR water level) and 1.9 m AHD (100-year ARI + 0.4 m for SLR water level). The testing indicated that at this placement density no damage to the structure was observed at water levels 1.5 m AHD and 1.6 m AHD. At 1.9 m AHD three units were displaced, resulting in less than 1% damage.

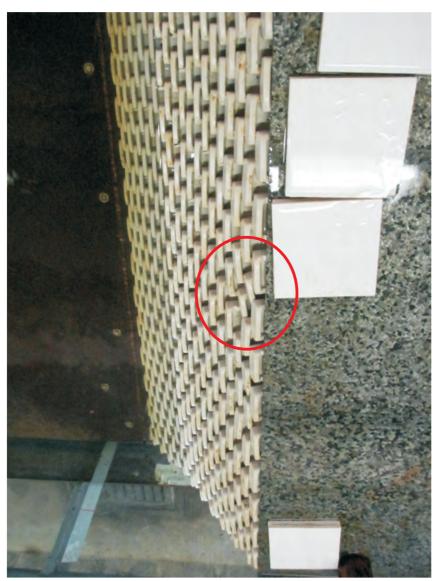
a) Cross-section 2 - placement density 10.8 units/m², WL 1.9m AHD, after 2000 waves, note displacement of three units resulting in minor damage (<1%) on the wall in addition to displacement of capping

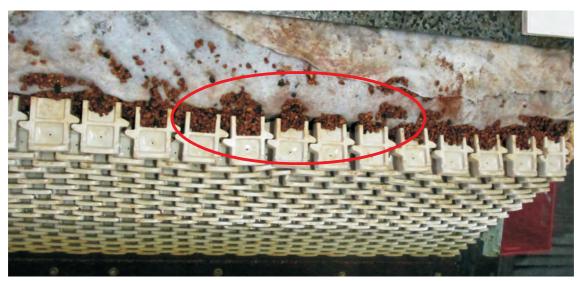
b) Cross-section 2 - placement density 10.8 units/m², WL 1.9m AHD, after 2000 waves, note backfill partially washed away

- Other possible modes of failure loss of underlayer material. Suitable filter materials should be incorporated in the prototype design in order to satisfy filter rules and avoid washout of underlayer materials as well as ensure efficient drainage of overtopping waves. The leaching of sand from behind the model structure highlighted the structural significance of utilising a suitable geofabric filters such as Terrafix 1200R, 900R and Elcomax 600R.

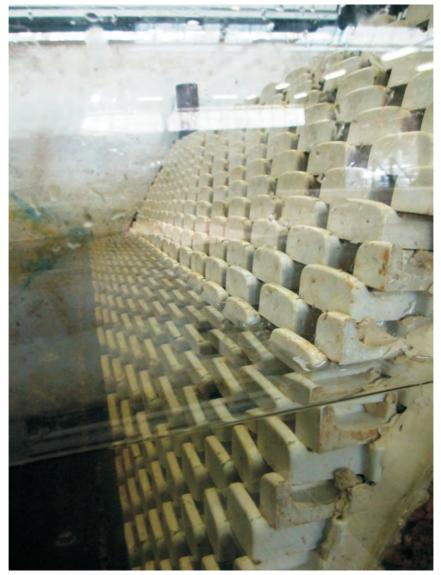
Cross-section 2 - placement density 10.8 units/m², WL 1.9m AHD, after 2000 waves, note displacement of three units resulting in minor damage (<1%), another view

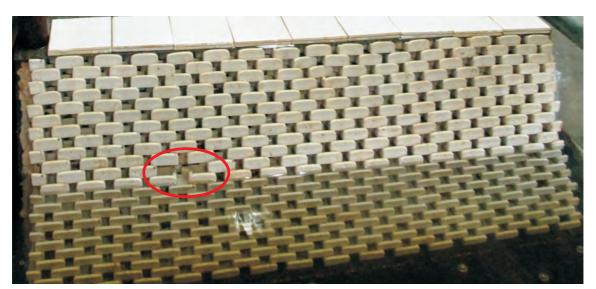
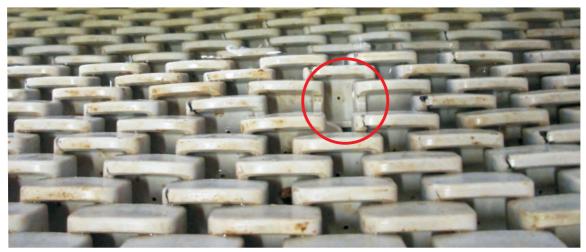
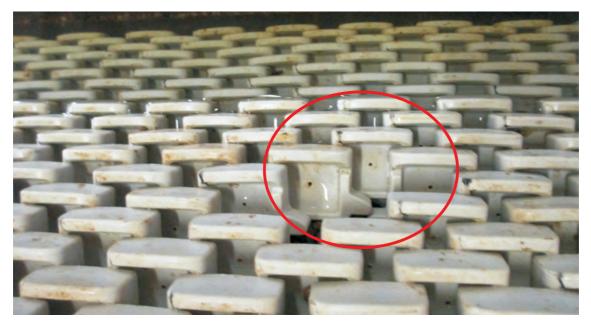
- Testing modes of failure. Although the structure did not fail during testing it is customary to initiate possible modes of failure and test these modes under design conditions. Two possible modes of failure were tested, the first consisting of a single unit being removed from the structure. The subsequent test using 2000 waves did not result in any progressive deterioration to the stability condition of the structure. The second mode of failure consisted of two adjacent units being removed. Similar to the previous result there was no further deterioration to the stability of the structure.

a) Testing possible modes of failure. Cross-section 2 - placement density 10.8 units/m², WL 1.9m AHD, one unit removed, after testing, no further damage was recorded

b) Testing possible modes of failure. Cross-section 2 - placement density 10.8 units/m², WL 1.9m AHD, one unit removed, after testing, no further damage was recorded

c) Testing possible modes of failure. Cross-section 2 - placement density 10.8 units/m², WL 1.9m AHD, one unit removed, after testing, no further damage was recorded, another view

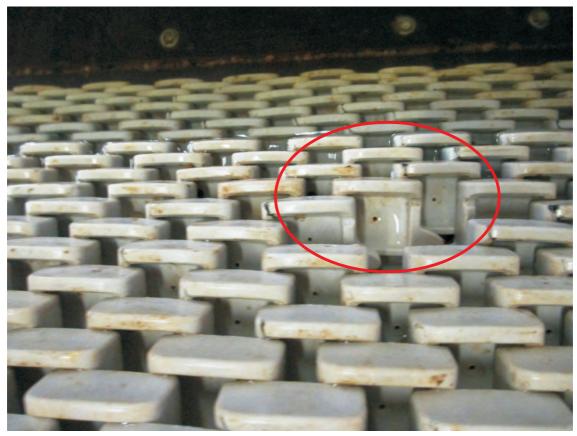
b) Testing possible modes of failure. Cross-section 2 - placement density 10.8 units/m², WL 1.9m AHD, two units removed, after testing, no additional damage
